# PRELIMINARY ASSESSMENT

Recycling Place

12 West Southern Mesa, Arizona 85210 Maricopa County

December 30, 1996

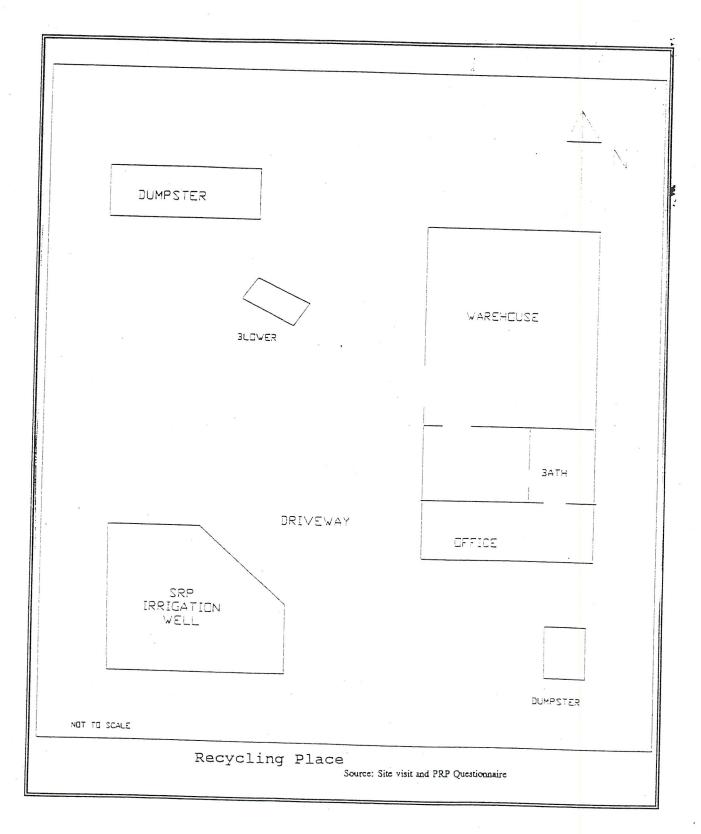
Figure 2-2 Site Layout

The Recycling Place site is located on approximately 1.5 acres of land in an industrial-zoned area in Mesa, Maricopa County, Arizona. The property parcel number is 13932016C. The site is bordered to the south by Southern Avenue, to the west by a railroad spur, to the north by Wonder Clean and to the east by Wonder Clean and Michelin Tire. The site includes a building which contains a small office, bathroom, and an inside warehouse area. (See Figure 2-2: Recycling Place Site Layout). The entire property is fenced and has two secured gates (south and east sides). Approximately half of the site is either covered by concrete or asphalt. (3) (See Figure 2-2)
